historic structure report  
architectural data section

# HOPEWELL VILLAGE

## THE IRONMASTER'S HOUSE

THE IRONMASTER'S HOUSE  
HOPEWELL VILLAGE NATIONAL HISTORIC SITE  
HOPEWELL, PENNSYLVANIA

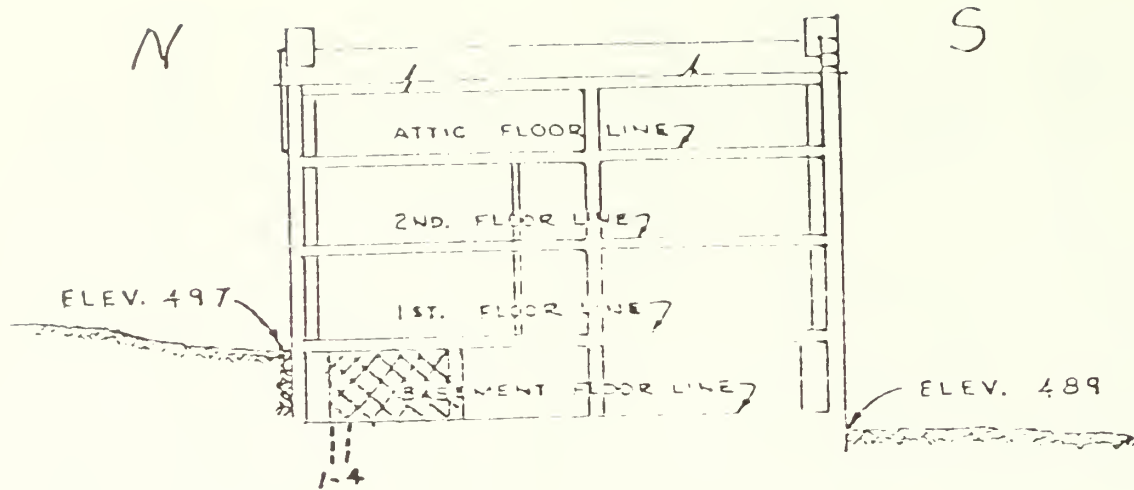
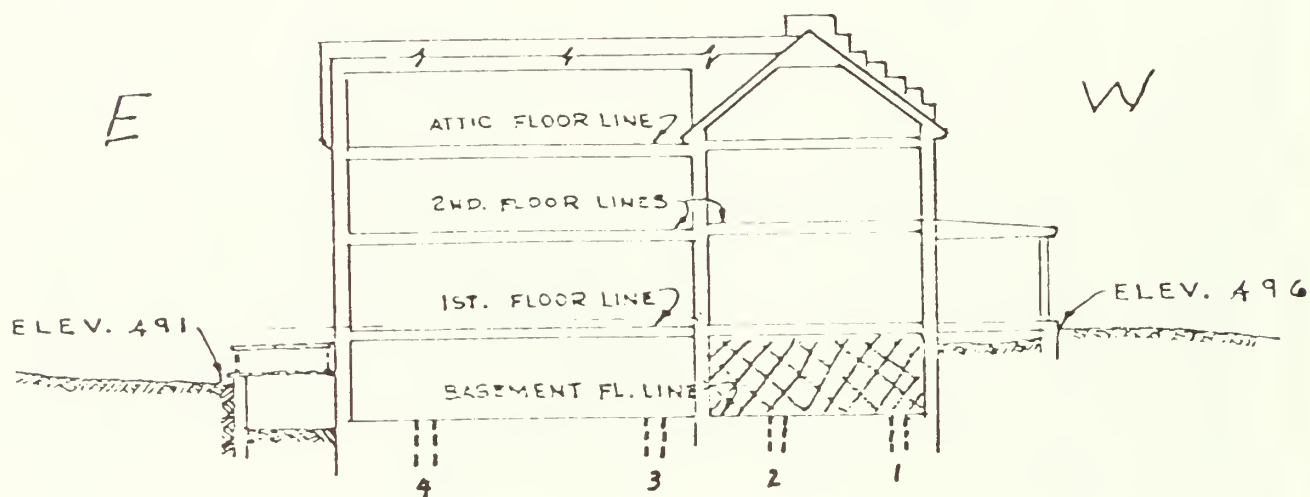
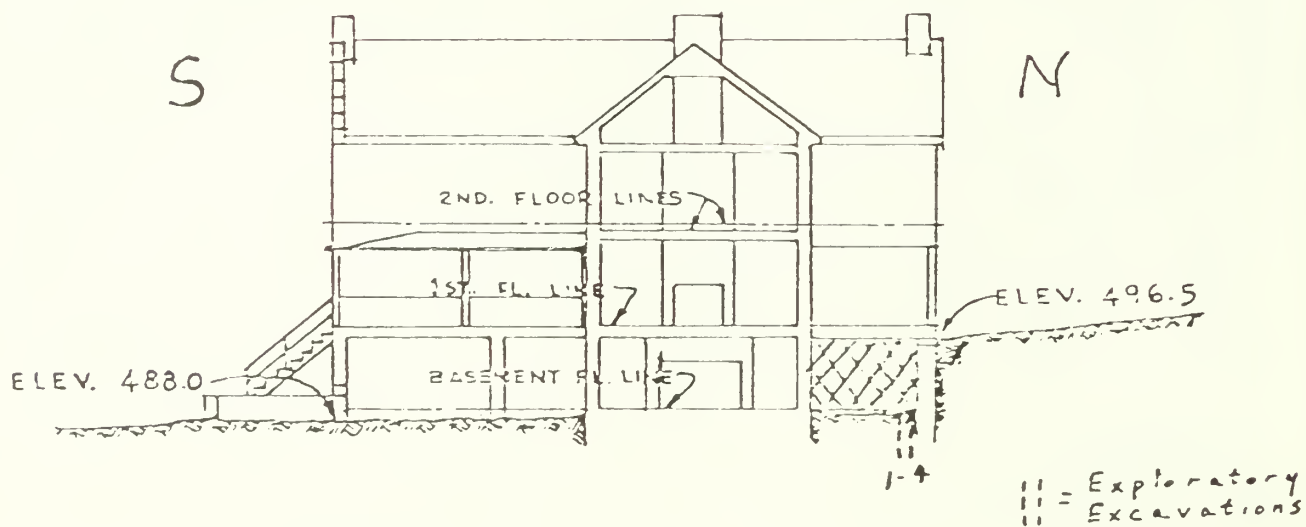
SCHEMATIC DRAWINGS OF PROPOSED PLANS TO INSULATE AND WATERPROOF THE  
NORTH WALL OF THE IRONMASTER'S HOUSE

The most critical problem affecting the Ironmaster's House is the excessive amount of moisture in the basement rooms caused by water vapor rising from the earth floor and condensation on the walls. Inadequate ventilation causes this excessive moisture to remain within these spaces with the result that floorboards, ceiling joists, and surface whitewash are deteriorating. To arrest this fabric deterioration and to rehabilitate the structural integrity of these rooms, the DSC professionals involved with the Hopewell Village project have devised various solutions to prevent further moisture intrusion.

b. Room 002 - open Window 005. Install a manual louver system in this window. The old heating duct through the wall between Rooms 001 and 002 should be removed. The hole in the wall which the duct passes through should remain. The earth floor should be leveled, a vapor barrier installed, and a concrete floor laid over the vapor barrier.

c. Room 003 - install a manual louver in Window 006. The earth floor should be leveled, a vapor barrier installed, and a concrete floor laid over the vapor barrier.

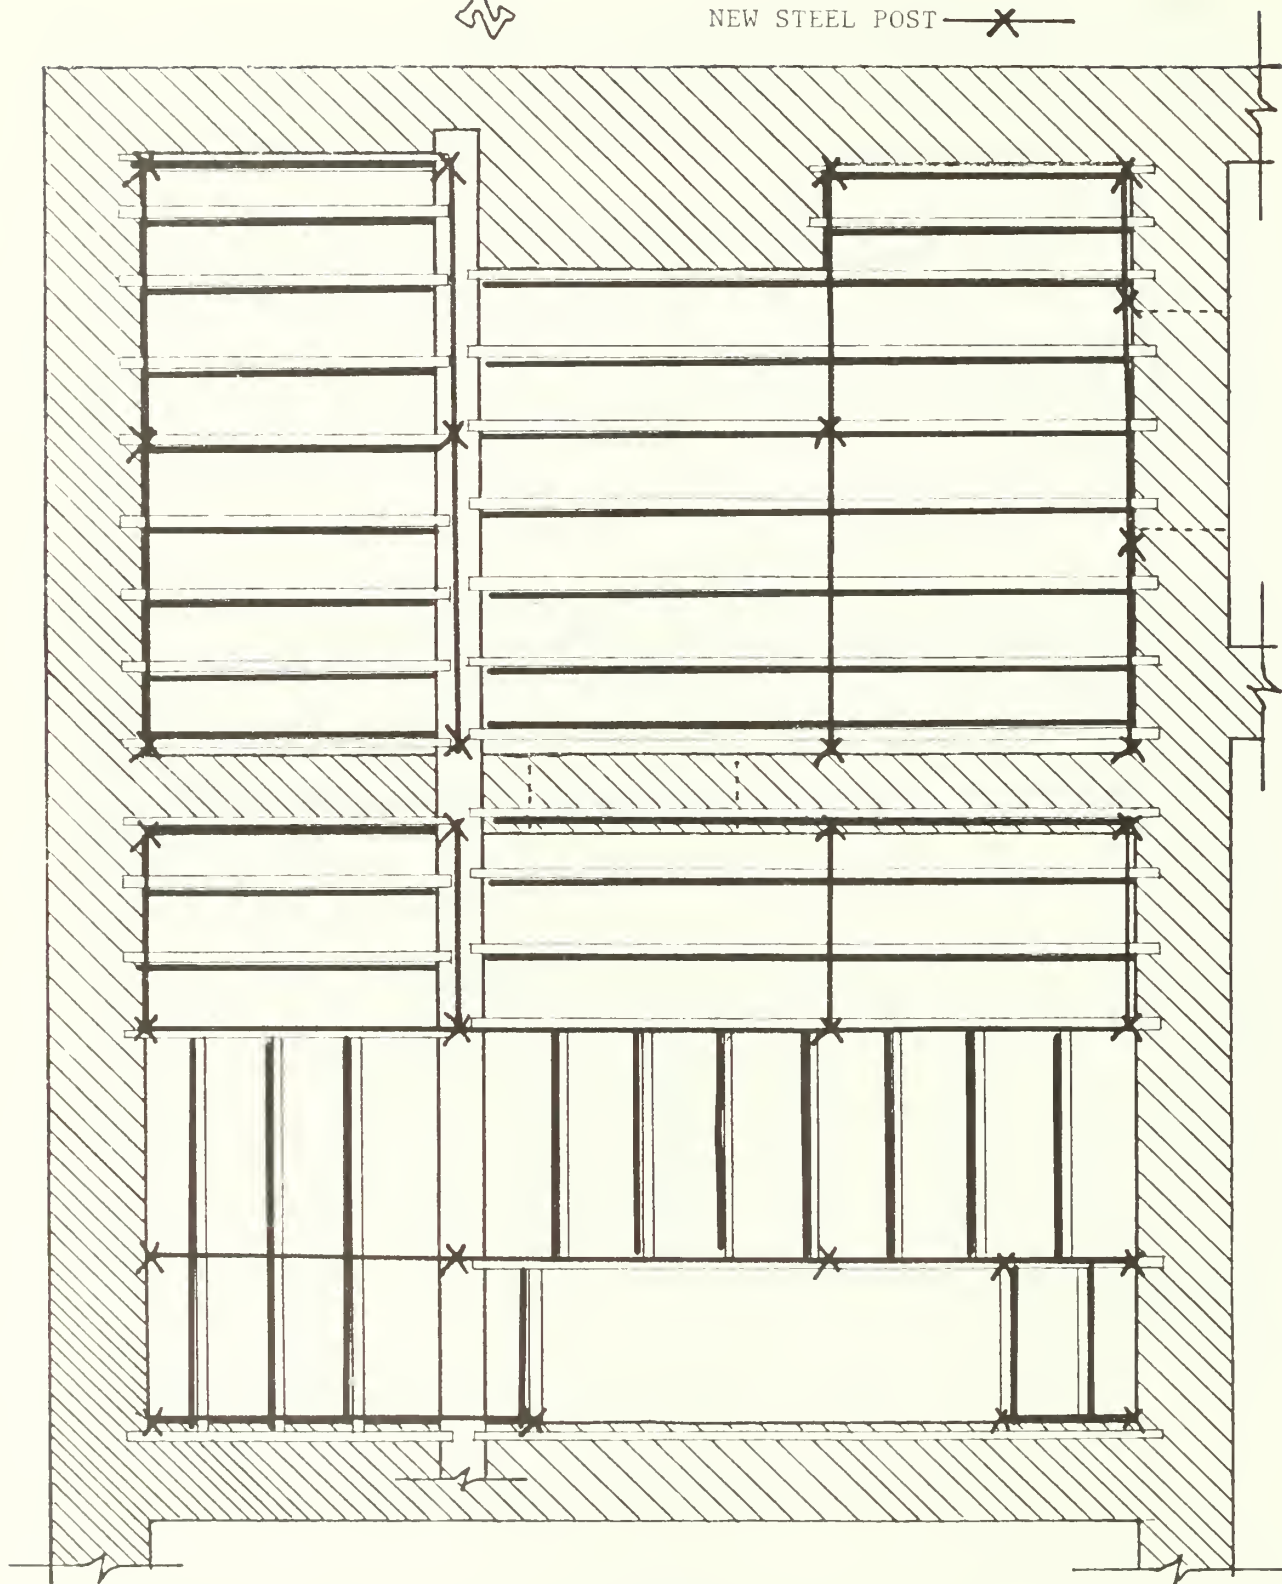
FIGURE 1  
FLOOR FRAMING  
ROOMS 102 & 103  
SCALE  $\frac{1}{4}'' = 1' - 0''$

The floor system has been damaged by the high moisture in the basement below. The summer beam has failed in shear on one side. New floor joists can be added alongside the existing joists. The new joists and cracked summer beam should rest on steel beams and columns (see Figure 1). The footing pads for the columns will have to extend through the historic mortar matrix floor below. In order to properly support the joists, 30 footing pads, 18" by 18" will be required. Fortunately, many of the pads would be located along the walls where the mortar matrix floor has been partially disintegrated. Even so, this work should be monitored by an archeologist.

- a. Replace flashing on all roofs
- b. Install a vapor barrier in Rooms 002, 003, 004, and 005
- c. Rebuild the stairs in Room 002
- d. Replace the floors in Rooms 004 and 005
- e. Strengthen the summer beam in Room 101
- f. Strengthen the entire floor framing system in Rooms 102, and 103 (see Figure 1)
- g. Replace visitor barrier at stairs in Room 102
- h. Rebuild the summer beam in Room 104
- i. Construct a new column to support the bathroom

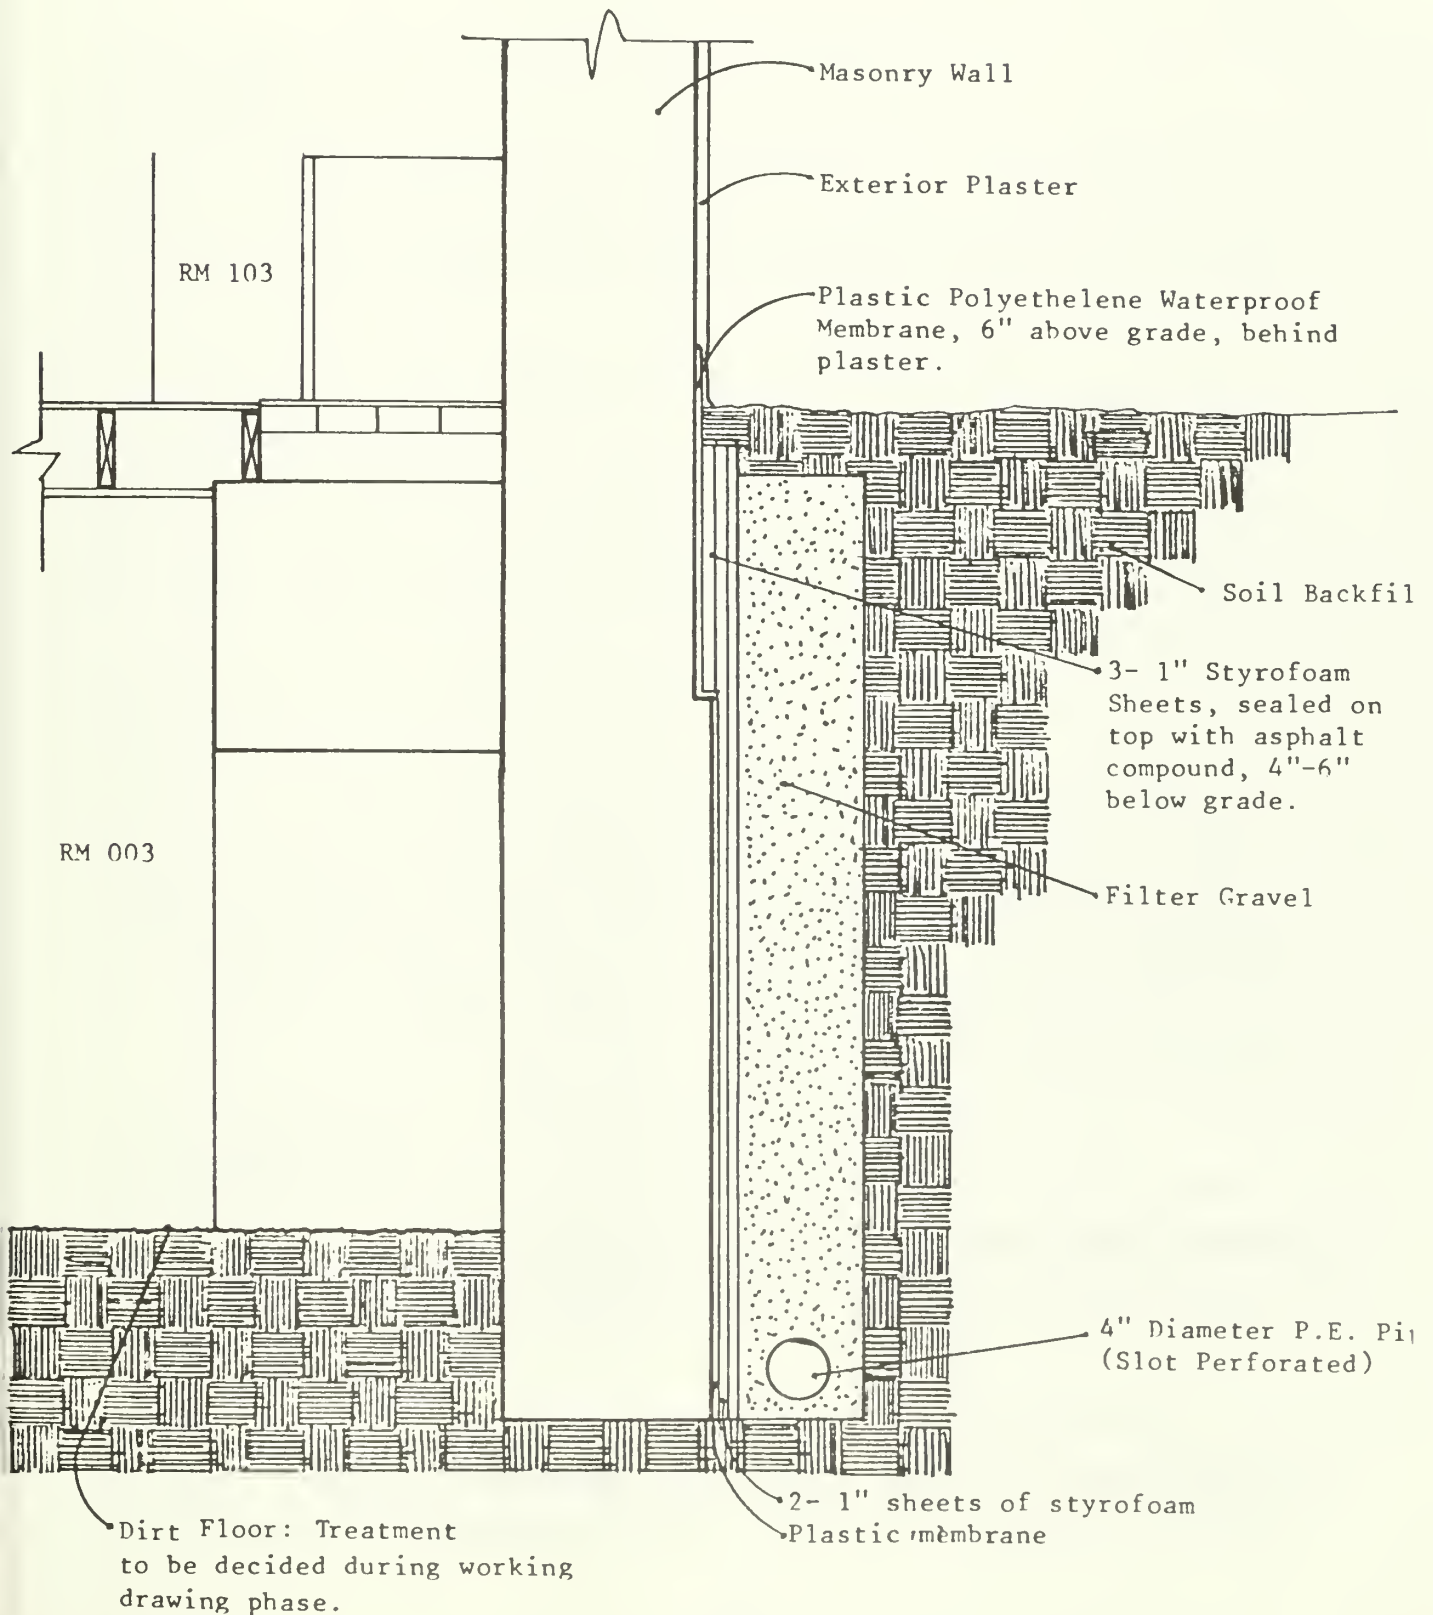
SCHEMATIC DRAWING OF ARCHITECTS' PROPOSAL FOR NORTH WALL INSULATION,  
WATERPROOFING, AND DRAINAGE.

Rooms 002 and 003 are not open to the public but are entered on occasion by park maintenance personnel. However, the evidence shows that the ceiling beams are rotten and the summer beam is cracking due to structural failure. Because the condition of the basement structure directly influences the security of the visiting public on the first floor, the rehabilitation and reinforcement of the fabric in these rooms is of the highest priority.

1. Four alternatives for treating the floor, Rooms 002 and 003:

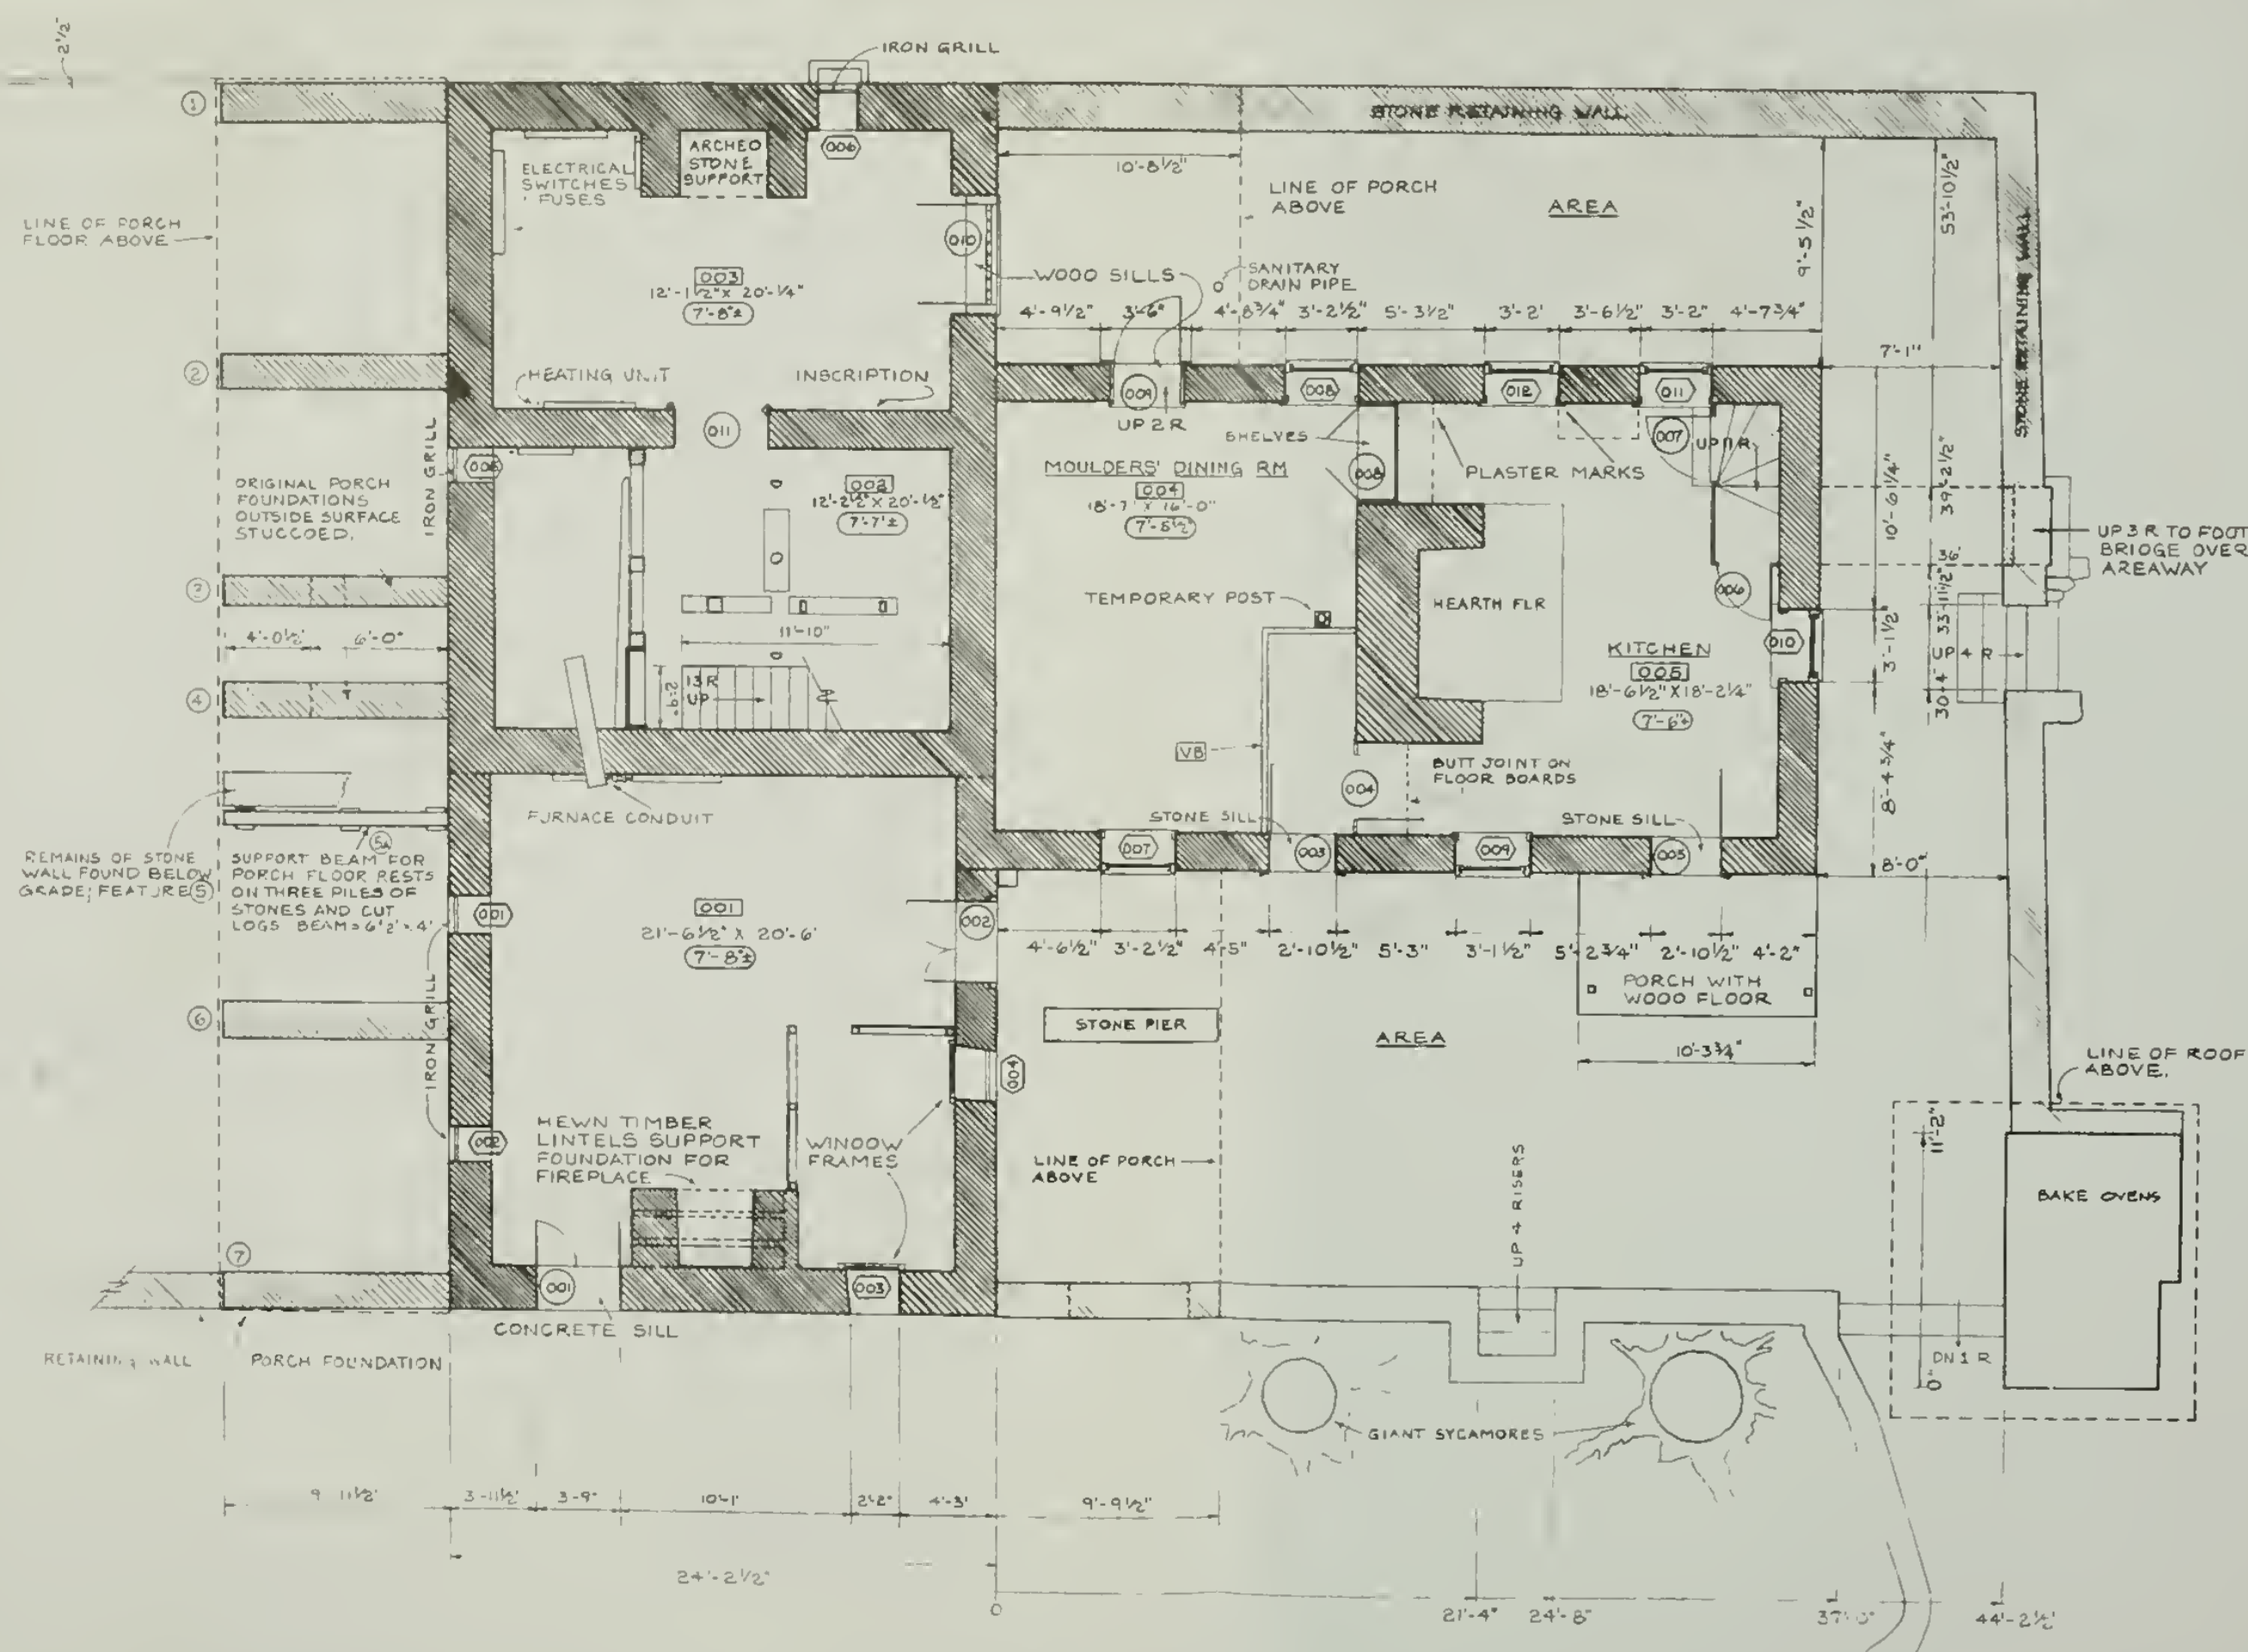
- 002 EARTH FLOOR, WALLS OF WHITE ROUGH PLASTER, WALLS AND CEILING JOISTS WHITEWASHED. ALL POSTS ARE TEMPORARY SUPPORTS, INSTALLED BY N.P.S., TO SECURE ROTTING CEILING JOISTS AND TO CARRY LIVE LOAD OF VISITORS IN HALLWAY OF FIRST FLOOR ABOVE.  
STAIRS: UP 13 R: 1 R @ 6"  
12 R @ 6"  
12 T @ 9 1/2"

- USE: BY PARK PERSONNEL; NO PUBLIC ACCESS OR EGRESS.
  - 003 INTERIOR CONDITIONS AND USE ARE THE SAME AS RM 002. INSCRIPTION: DATE AND INITIAL "S-1826" INSCRIBED IN PLASTER.

- 009 UP 2 RISERS, @ 6 3/4" AND 7 1/2"
  - 005 KITCHEN  
INTERIOR CONDITIONS AND USE SAME AS ROOM 004. MARKS ON PLASTER WALLS INDICATE PREVIOUS CUPBOARD.

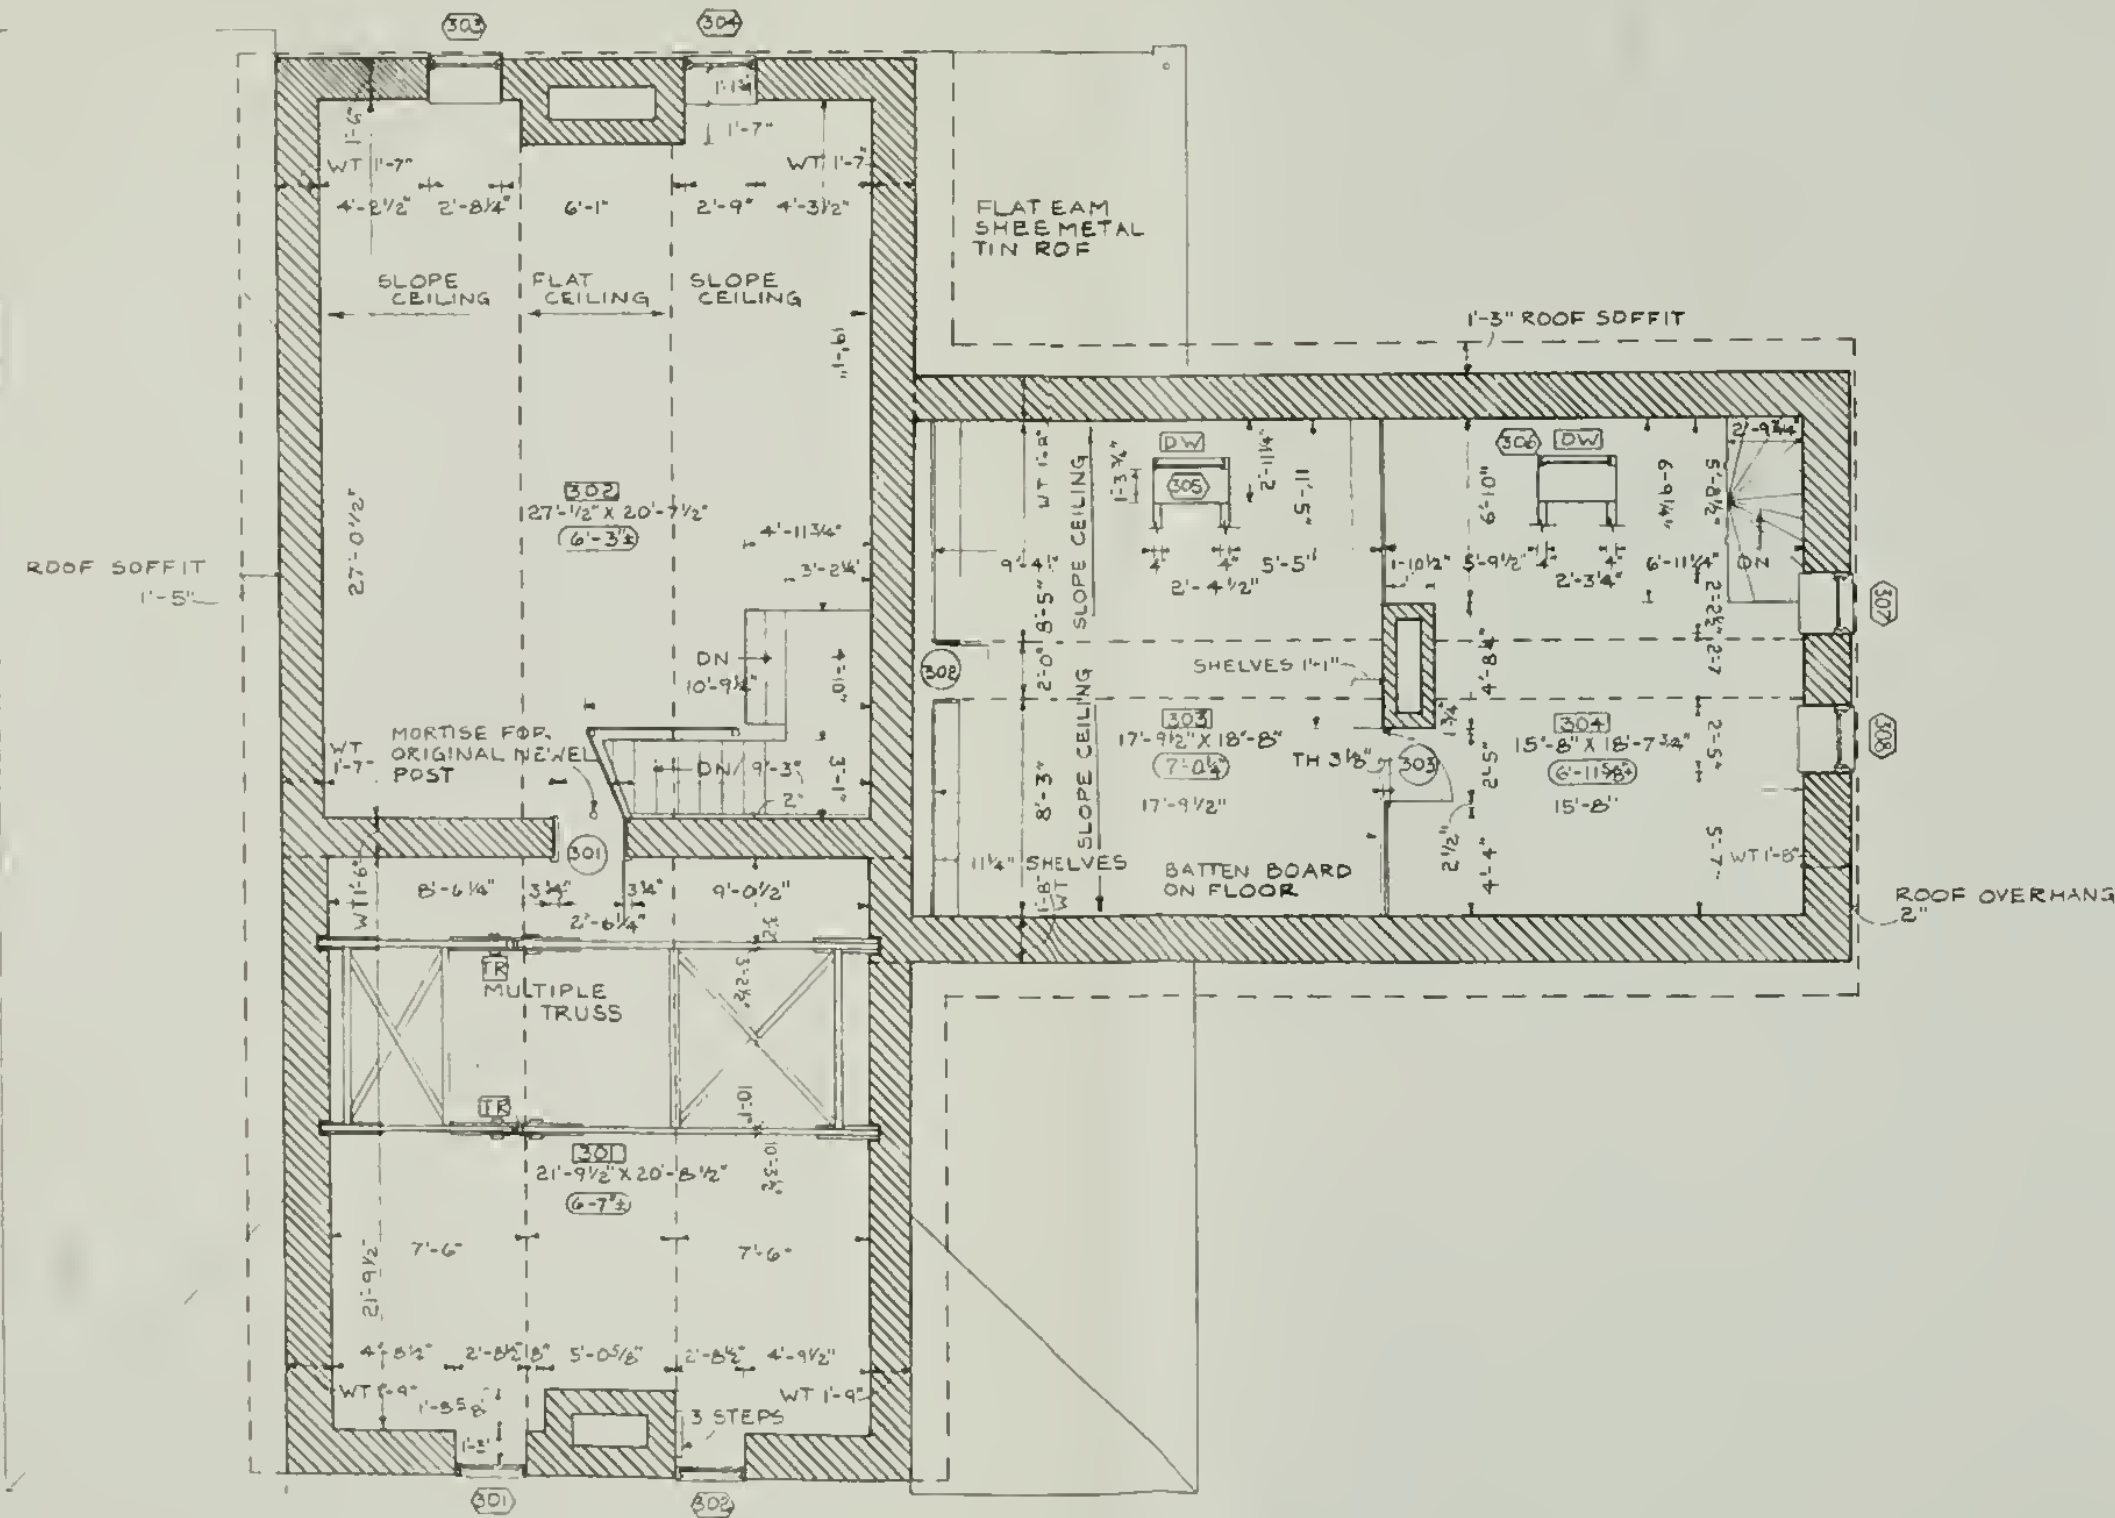
301 MULTIPLE TRUSS SYSTEM IN ATTIC DESIGNED BY N.P.S. IN 1958 AND ERECTED TO SECURE AND ORAW UP THE FAILING SUMMER BEAM IN FLOOR OF RM 201/CEILING RM 101 BY MEANS OF IRON ROOS AND TURNBUCKLES. TRUSS BOTTOM CORUS ARE 1 1/2" X 5/4" AND 2 1/2" X 5/4", ENDS RESTING IN LOAD BEARING MASONRY WALLS.

304 STAIRWAY: DN 13R  
NO POST AND RAILING ALONG EDGE OF STAIRWELL. TWO MORTISES IN FLOOR INDICATE MISSING POST OR PARTITION.

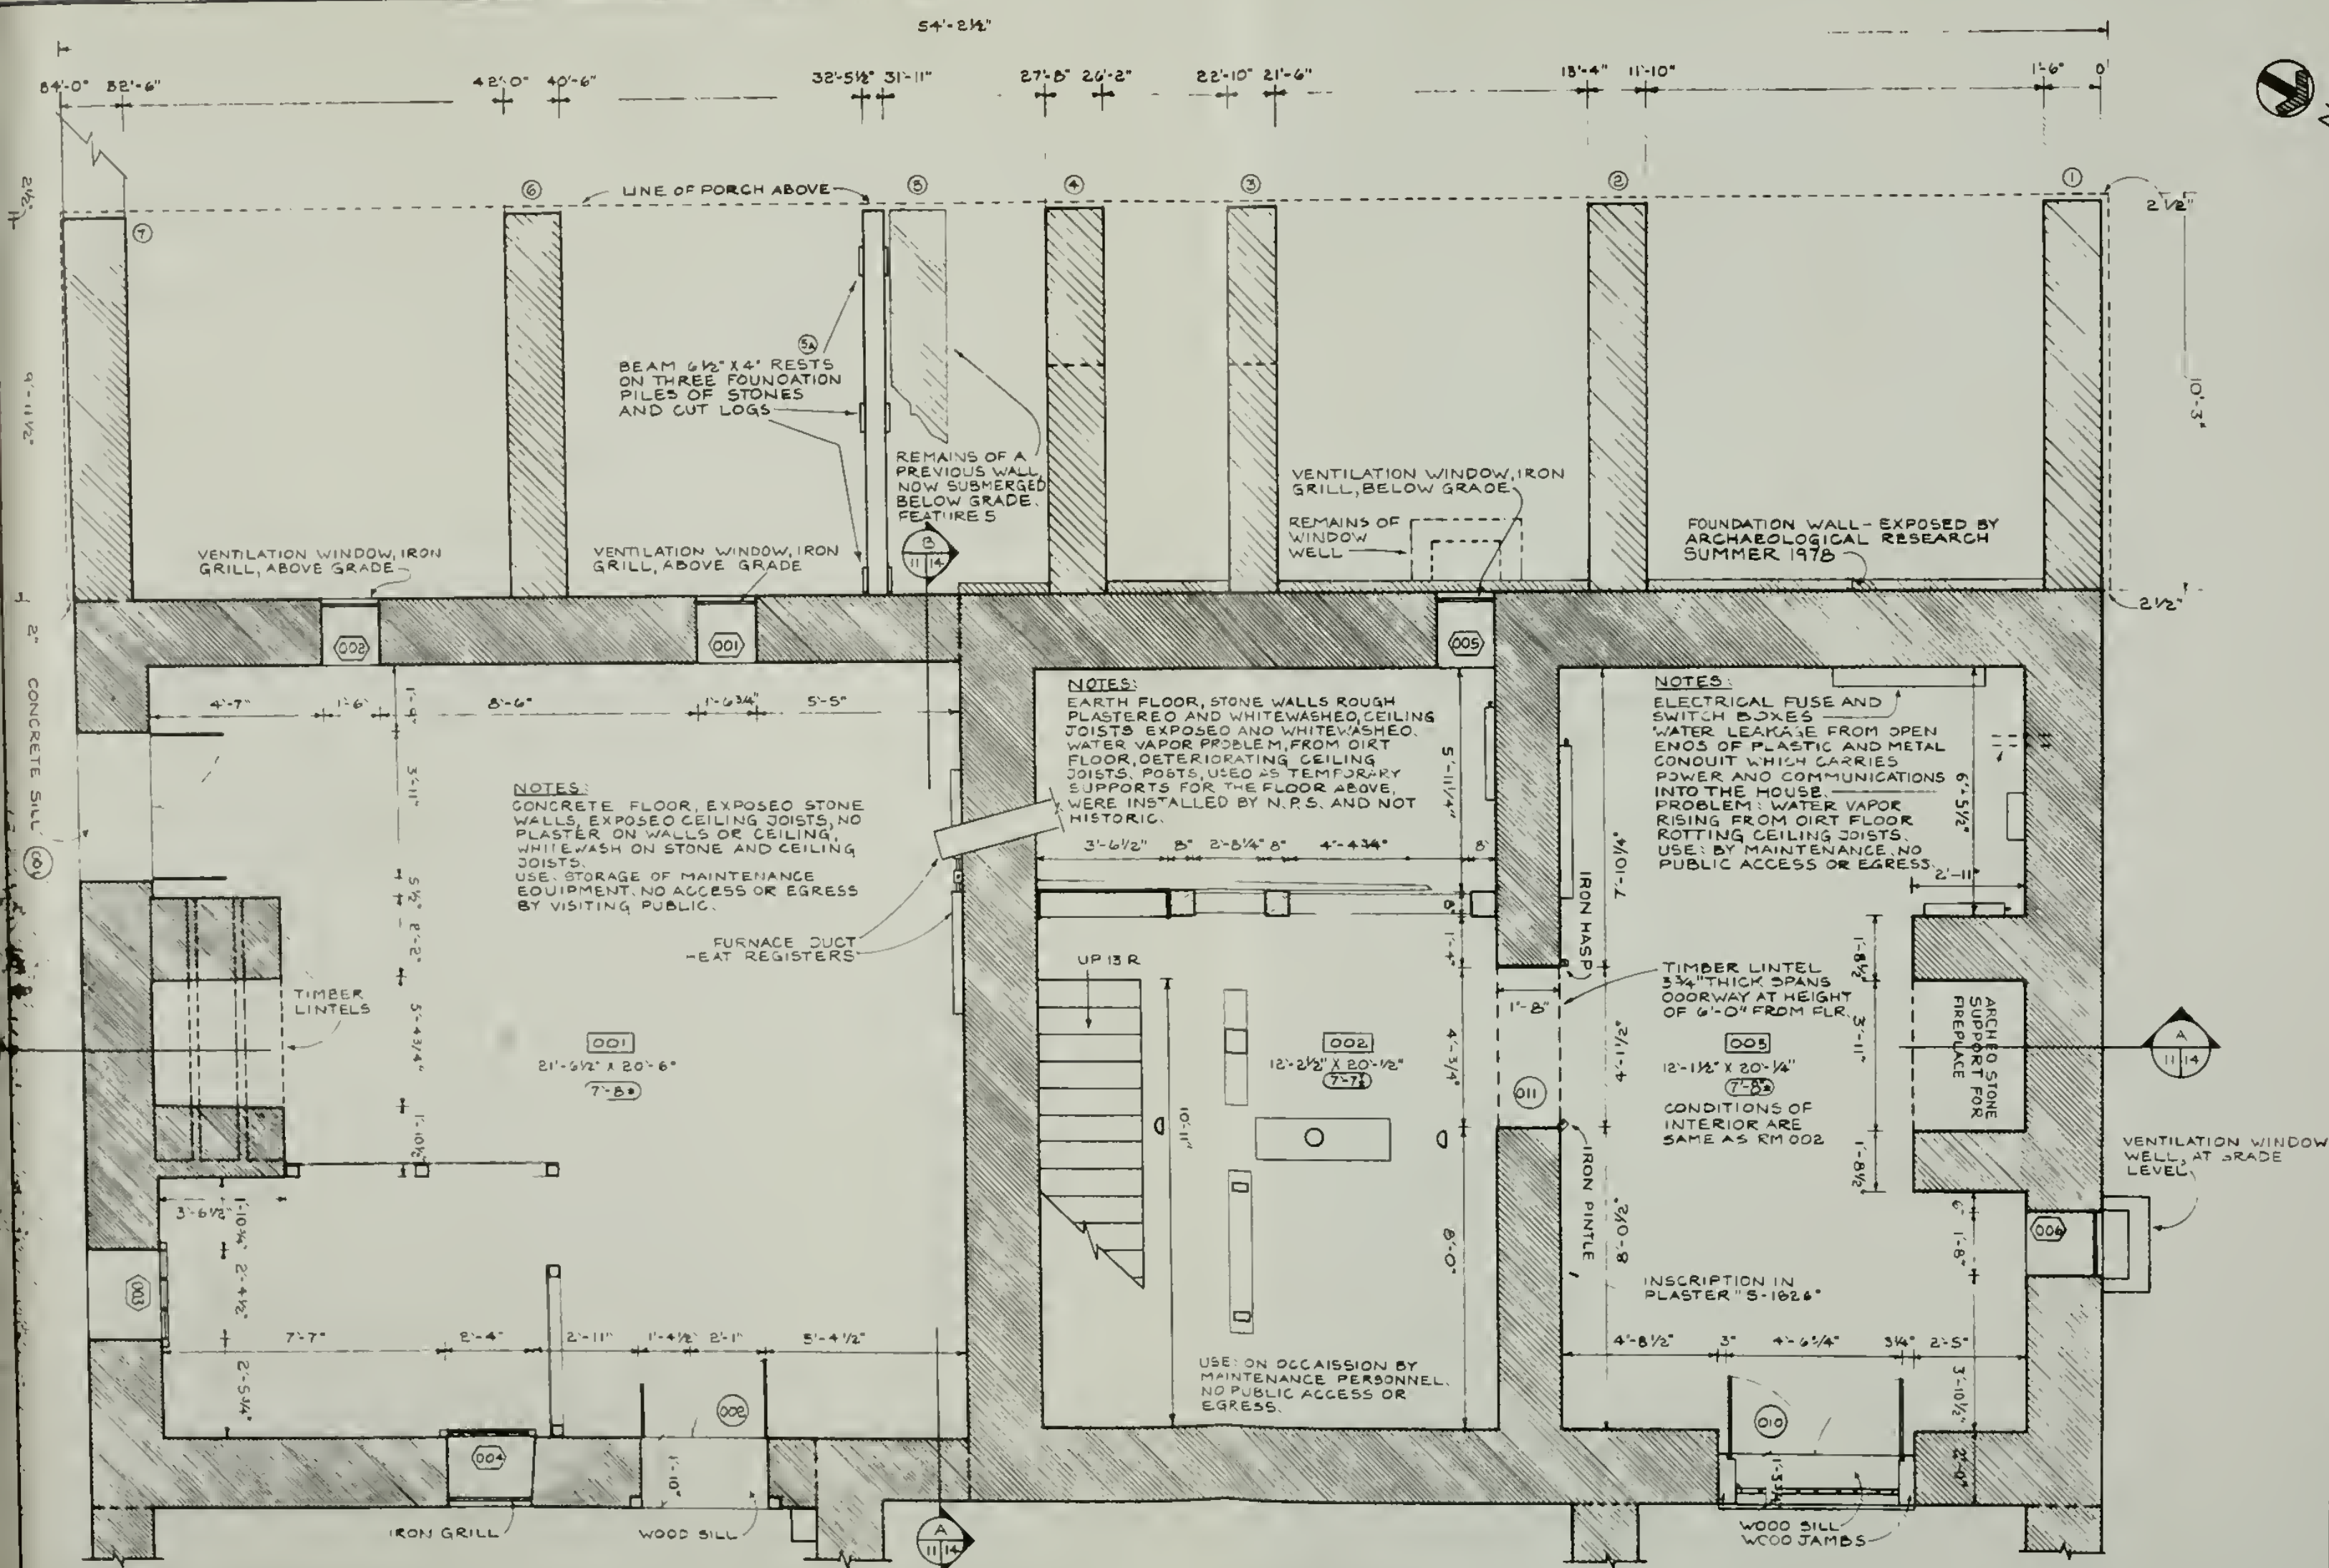
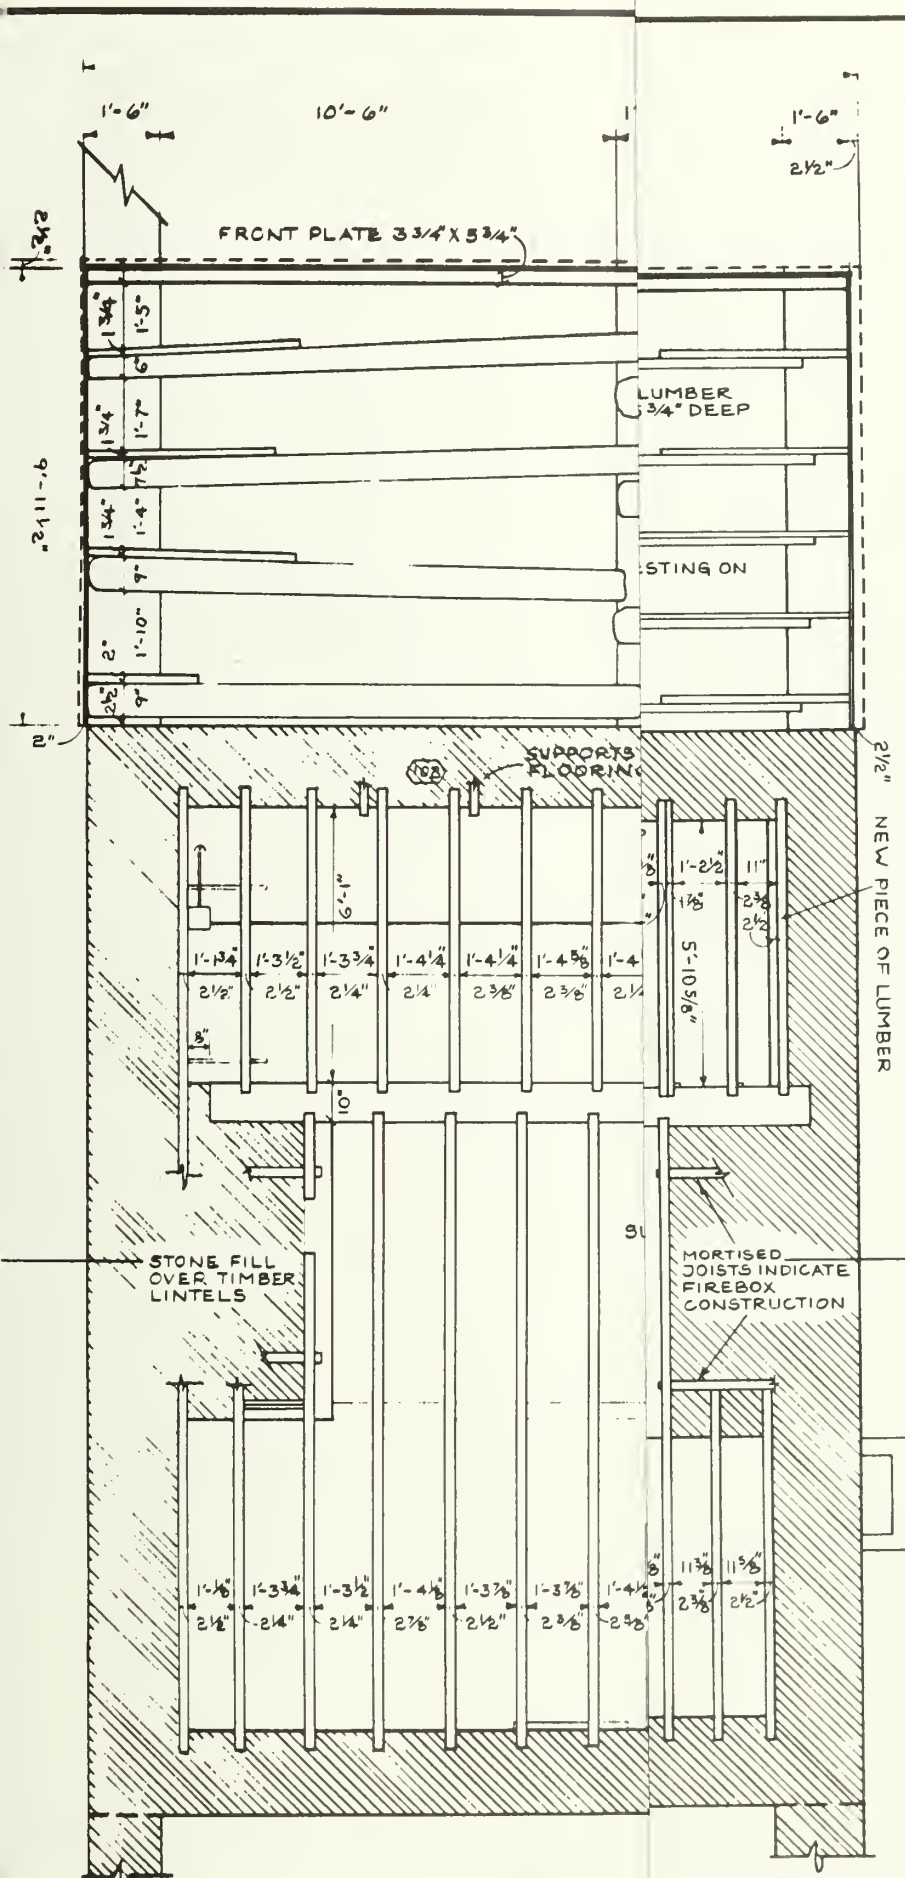
BASEMENT FLOOR PLAN 001-003  
FRONT PORCH FOUNDATION

**CEILING JOISTS - RMS 001-003**  
 REDOAK, MORTISED CONNECTIONS, DIMENSIONS 2 1/2" X 8 1/2". SIGNS OF DRY ROT ON JOIST DUE TO MOISTURE VAPOR EMITTED FROM THE EARTH FLOOR.

**NW CORNER OF PORCH IS SAGGING**, DUE TO ROT OF FRAMING FABRIC AT THAT POINT. SKIRT BOARD ROTTING WHERE TOUCHING GRADE LEVEL.

**HISTORIC PORCH BOARDS:**  
 NAIL HOLES ON HEWN TIMBER PORCH FRAMING SHOW NAIL SPACING 2 1/2" APART. THE 1970 HISTORIC FLOORING WAS PROBABLY T & G 5 5/8" X 1 1/8" AS EVINCED BY A SHIM PIECE OF THAT SIZE USED IN THE FRONT PILE SUPPORTING THE WOOD FOUNDATION BEAM DESIGNATED FEATURE NO. 5A.

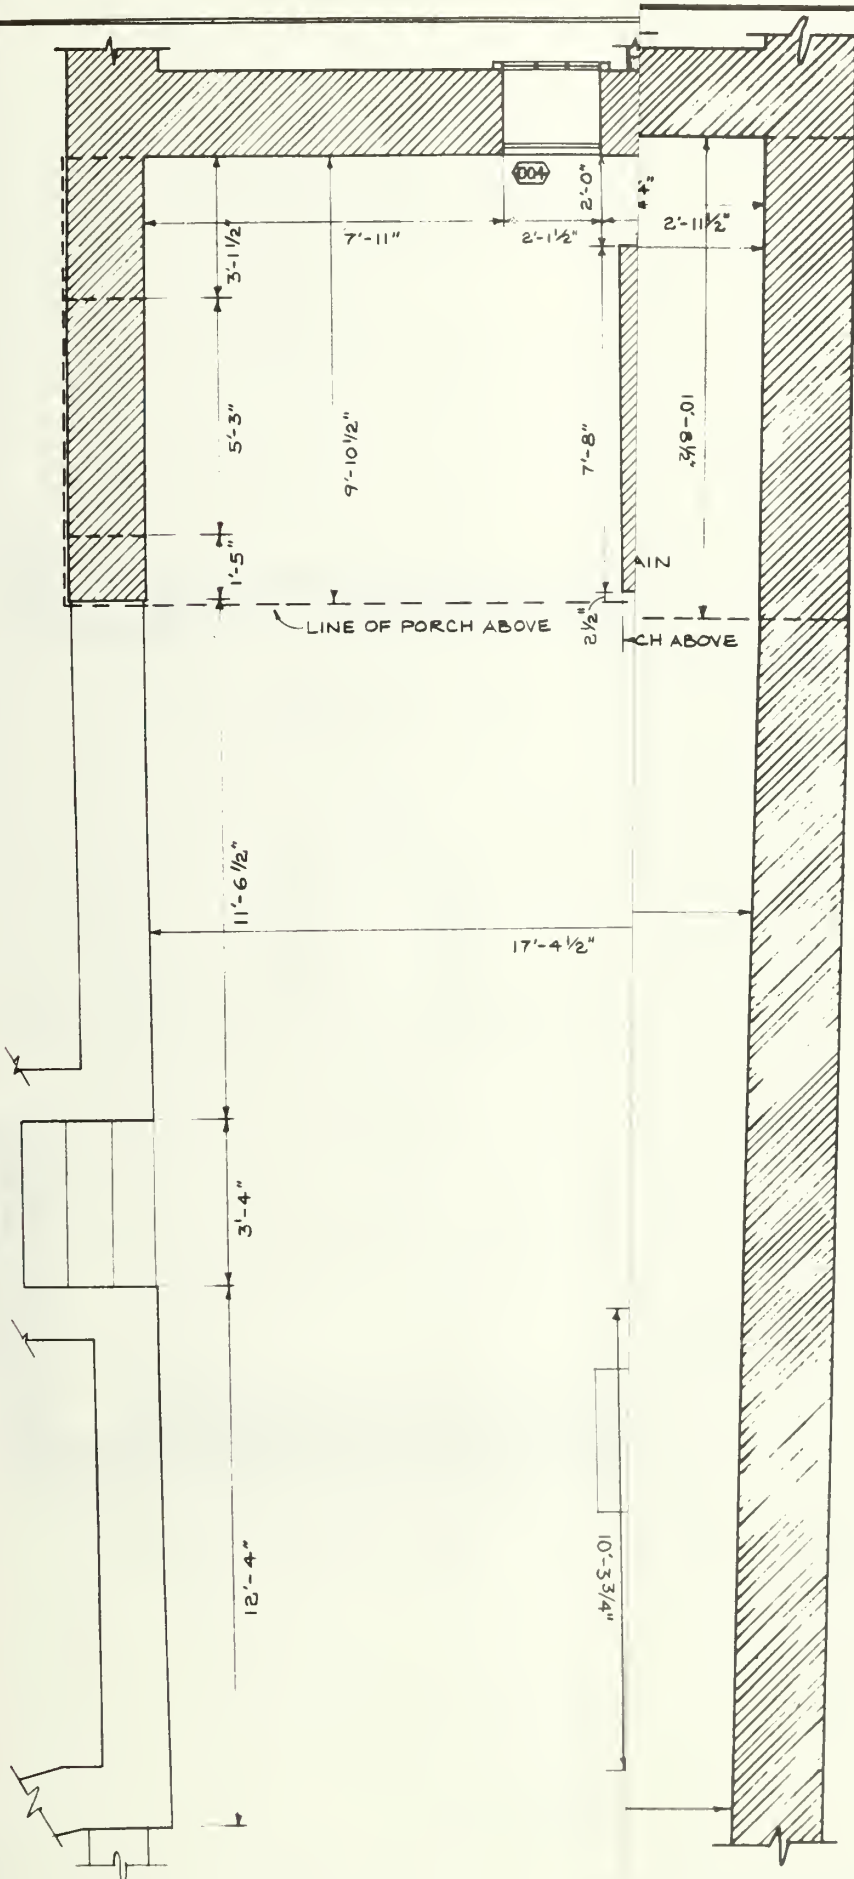
BASEMENT FLOOR PLAN

WALLS AND CEILINGS - PLASTERED AND WHITEWASHED. MOISTURE VAPOR CAUSING CONDENSATION ON WALLS AND FLAKING WHITE-WASH.

FLOOR BOARDS - T & G, 5 3/8" X 7/8", HEMLOCK, IN DETERIORATING CONDITION DUE TO MOISTURE VAPOR FROM SOIL UNDER TIMBER SLEEPERS. DEFLECTION IN PLACES CAUSED BY DETERIORATION AND/OR LACK OF ADEQUATE STONE SUPPORT OF SLEEPERS.

HEWN TIMBER SLEEPERS - OF VARIOUS WIDTHS, 5"-6" DEEP, SIGNS OF SURFACE ROT, IN PLACES NOT ADEQUATELY SUPPORTED BY STONES.

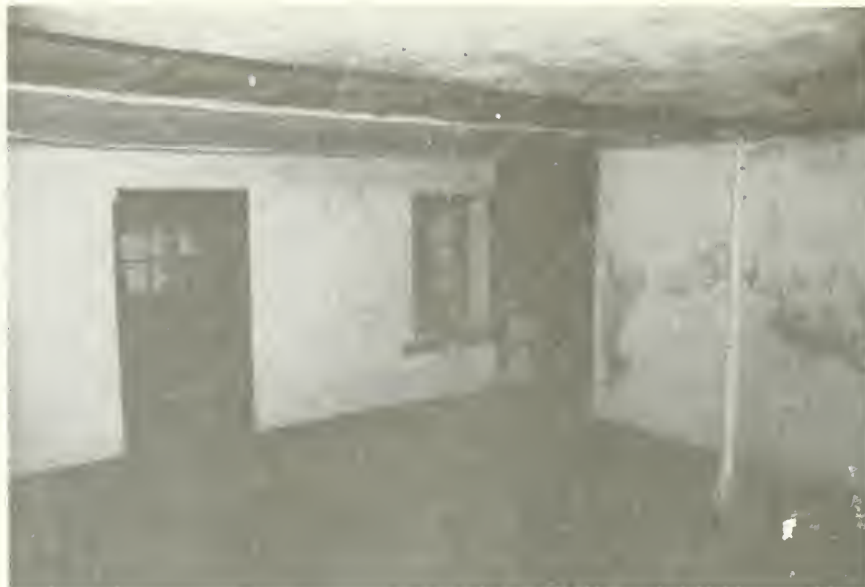
2. Room 004: moulder's dining room. Existing ceiling summer beam exposed; flooring removed, December 13, 1979.

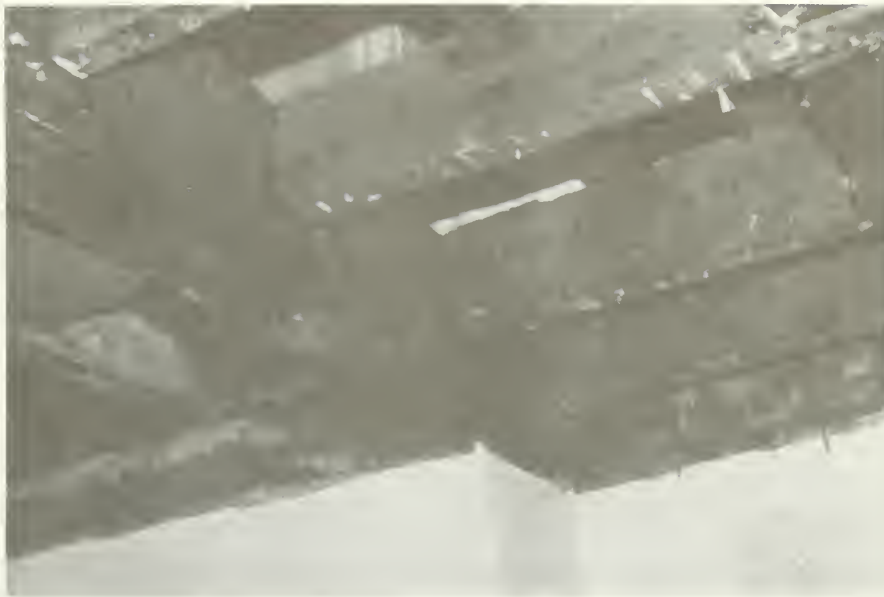
7. Room 101: southwest parlor. Existing ceiling summer beam and framing exposed at south wall pocket adjacent to chimney and near Window 103, December 13, 1979.
